**115-32-10250-2050 Correction**

*Stream:* 115-32-10250-2050

*Watershed:* Takhin River

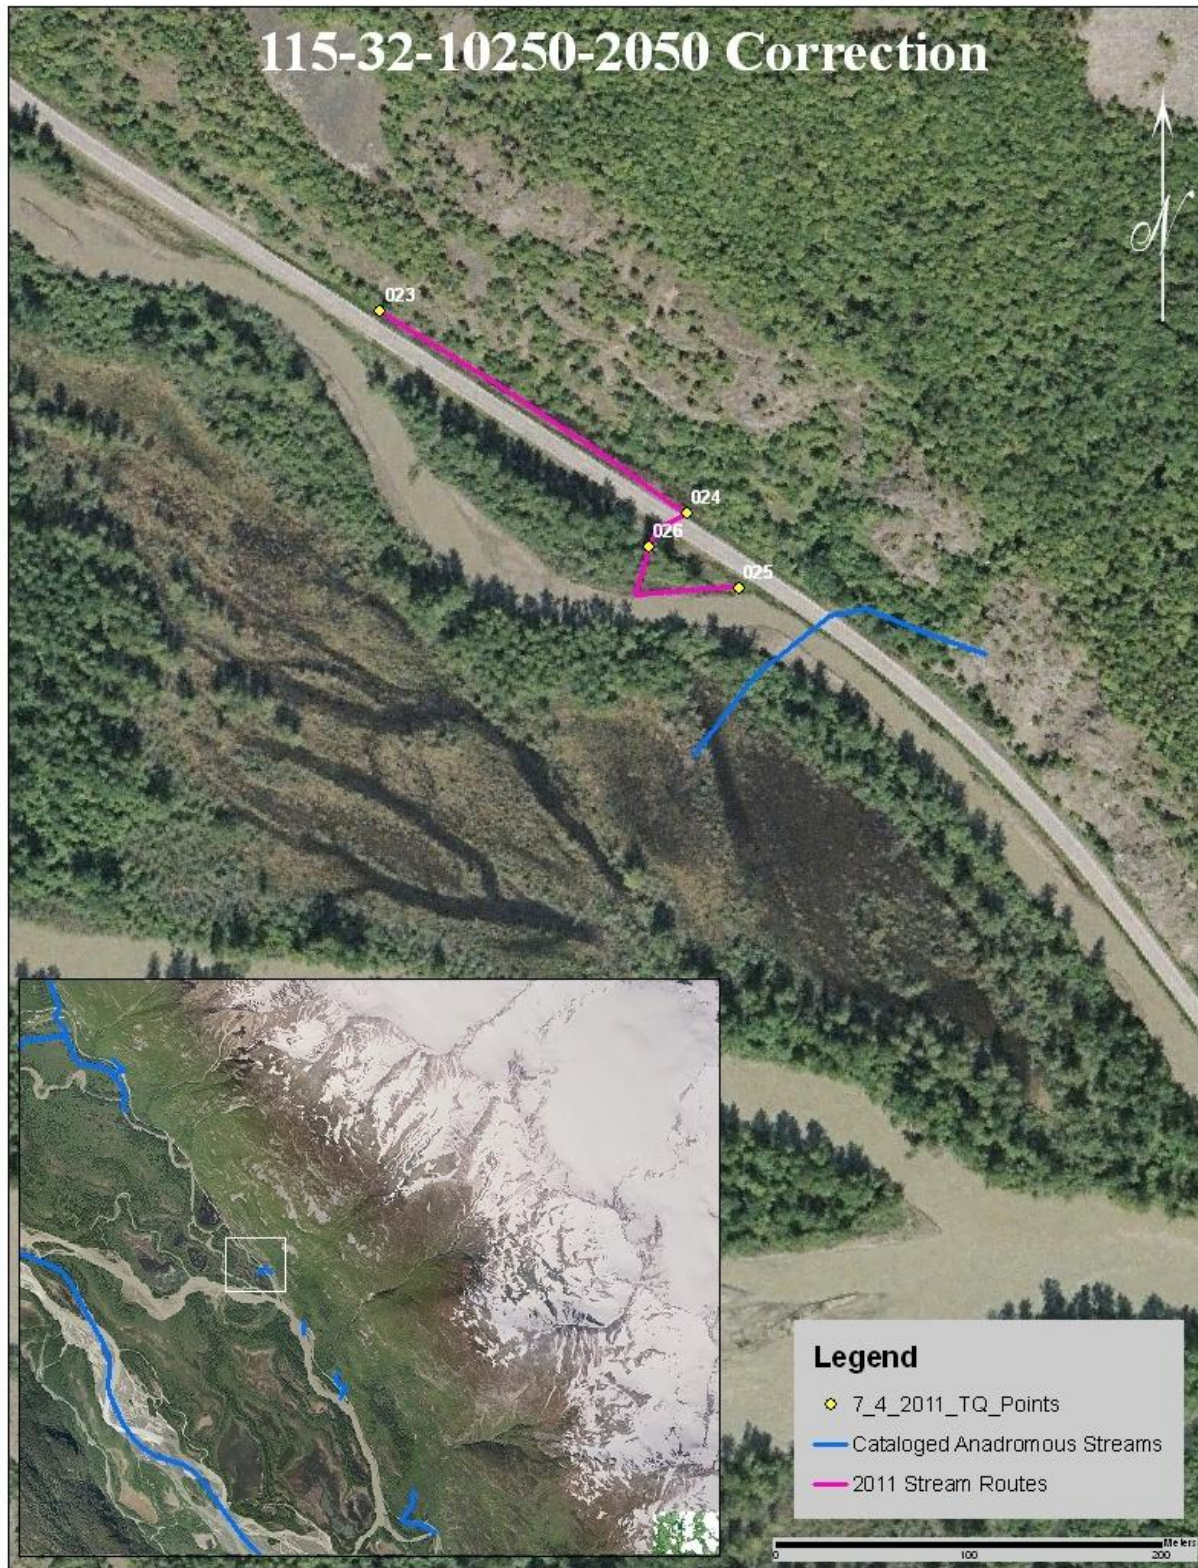
Figure 1:115-32-10250-2050 Correction Map

*Findings:* The actual upper and lower limit, as well as the route of this stream, differs from that indicated in the AWC.

*Notes:* This stream flows from a hillside, parallels the Haines Highway, and flows through a culvert in to a braid of the Chilkat. Coho salmon were captured at the upper and lower extents.

*Recommendations:* Update this stream in the AWC.
